TECHNICAL REPORT CERC-85-10

# WAVE STABILITY TESTS OF DOLOS AND STONE REHABILITATION DESIGNS FOR THE EAST BREAKWATER, CLEVELAND HARBOR, OHIO

Experimental Model Investigation

Coastal Engineering Research Center

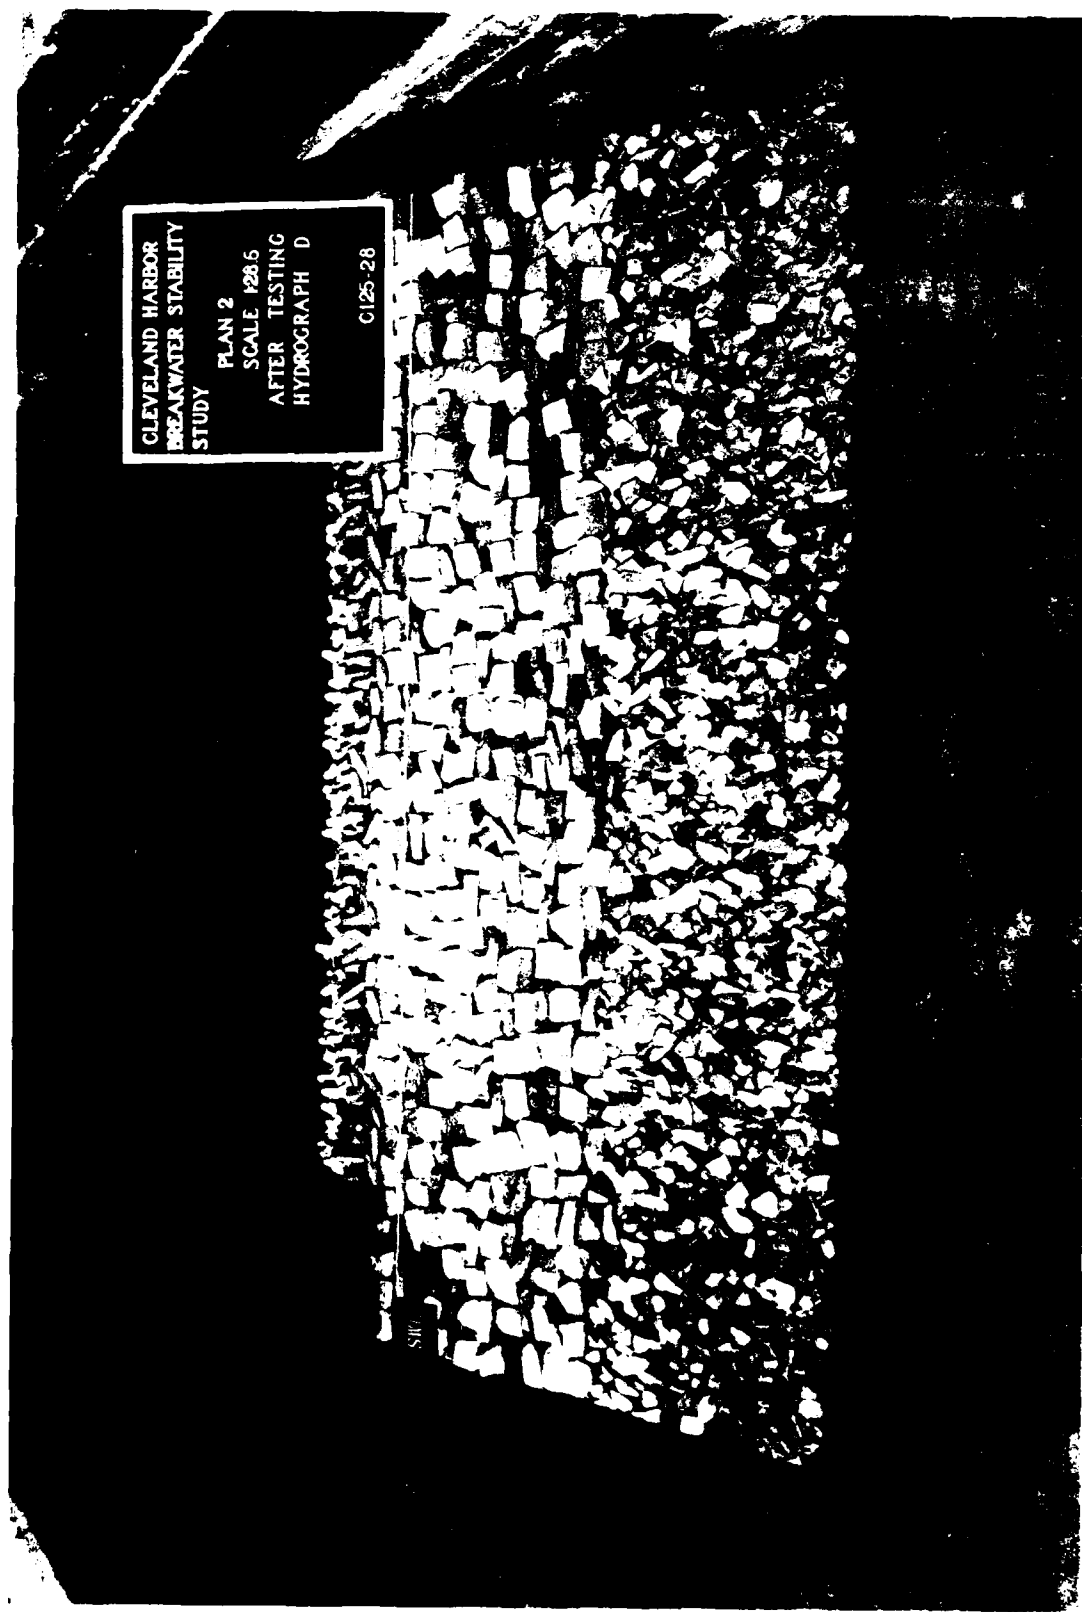
Photo 28. Harbor-side view of Plan 2 after testing Hydrograph D, first test section

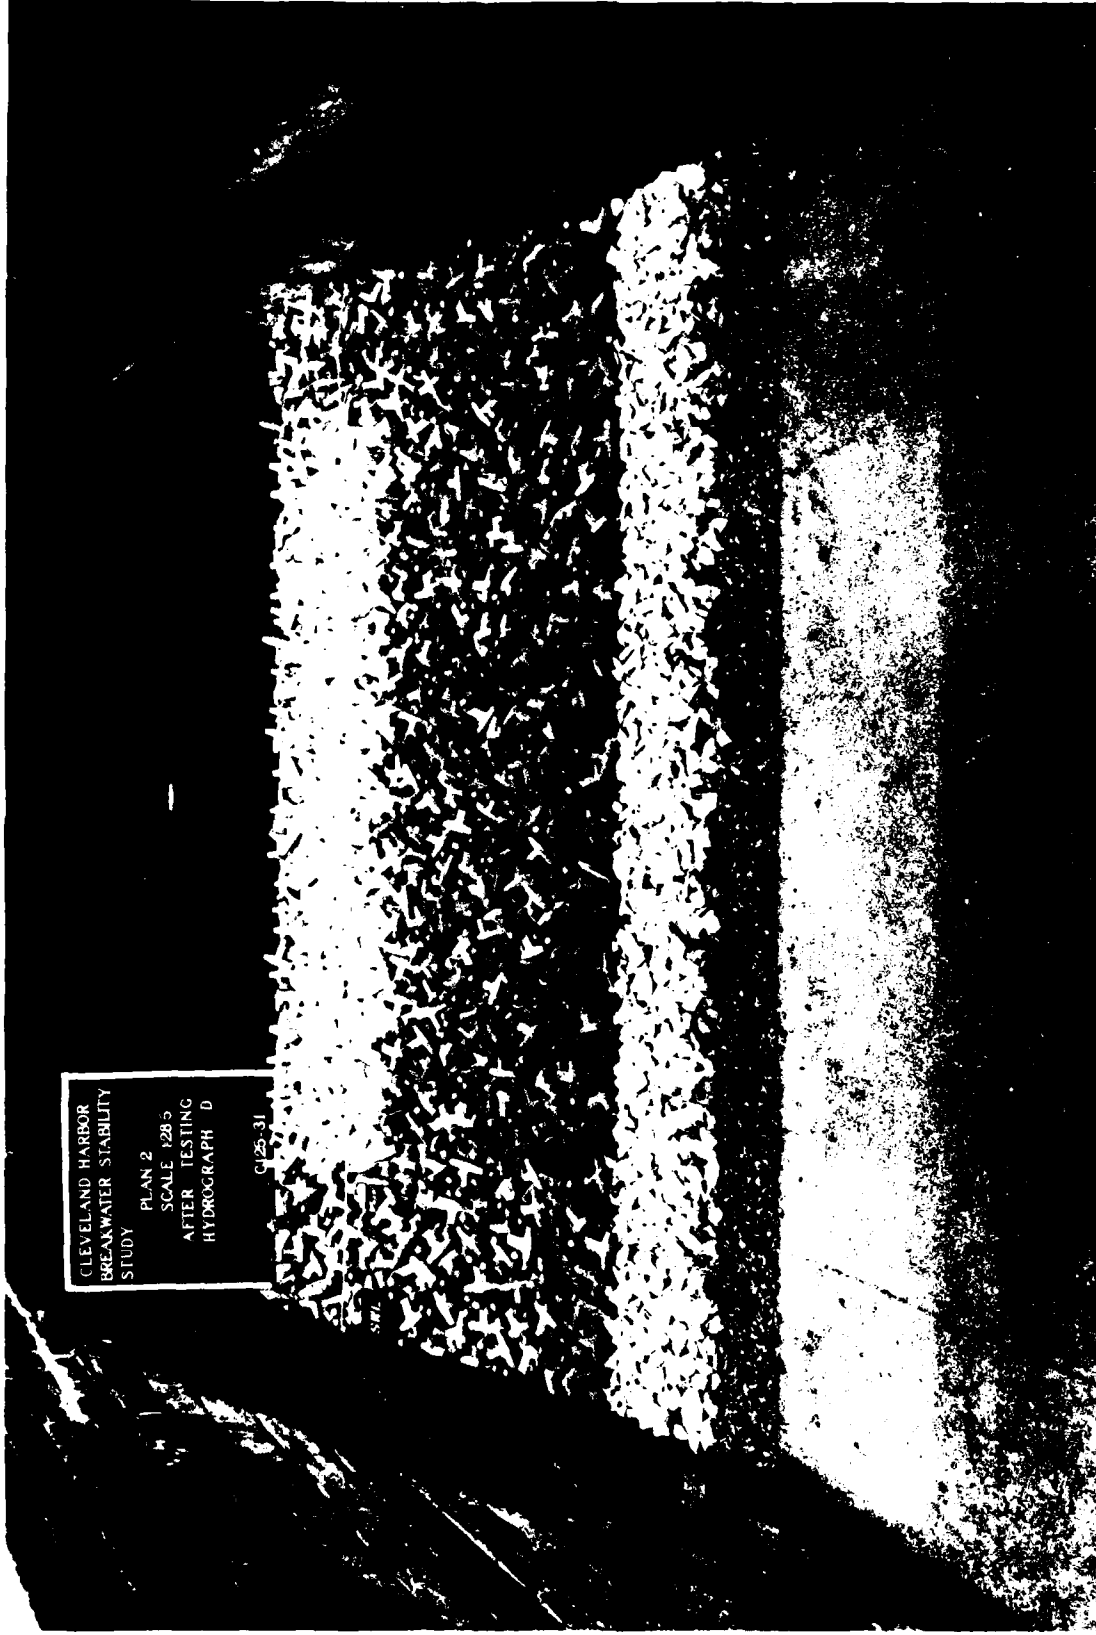
Photo 29. Lakeside view of Plan 2 after testing Hydrograph D, second test section

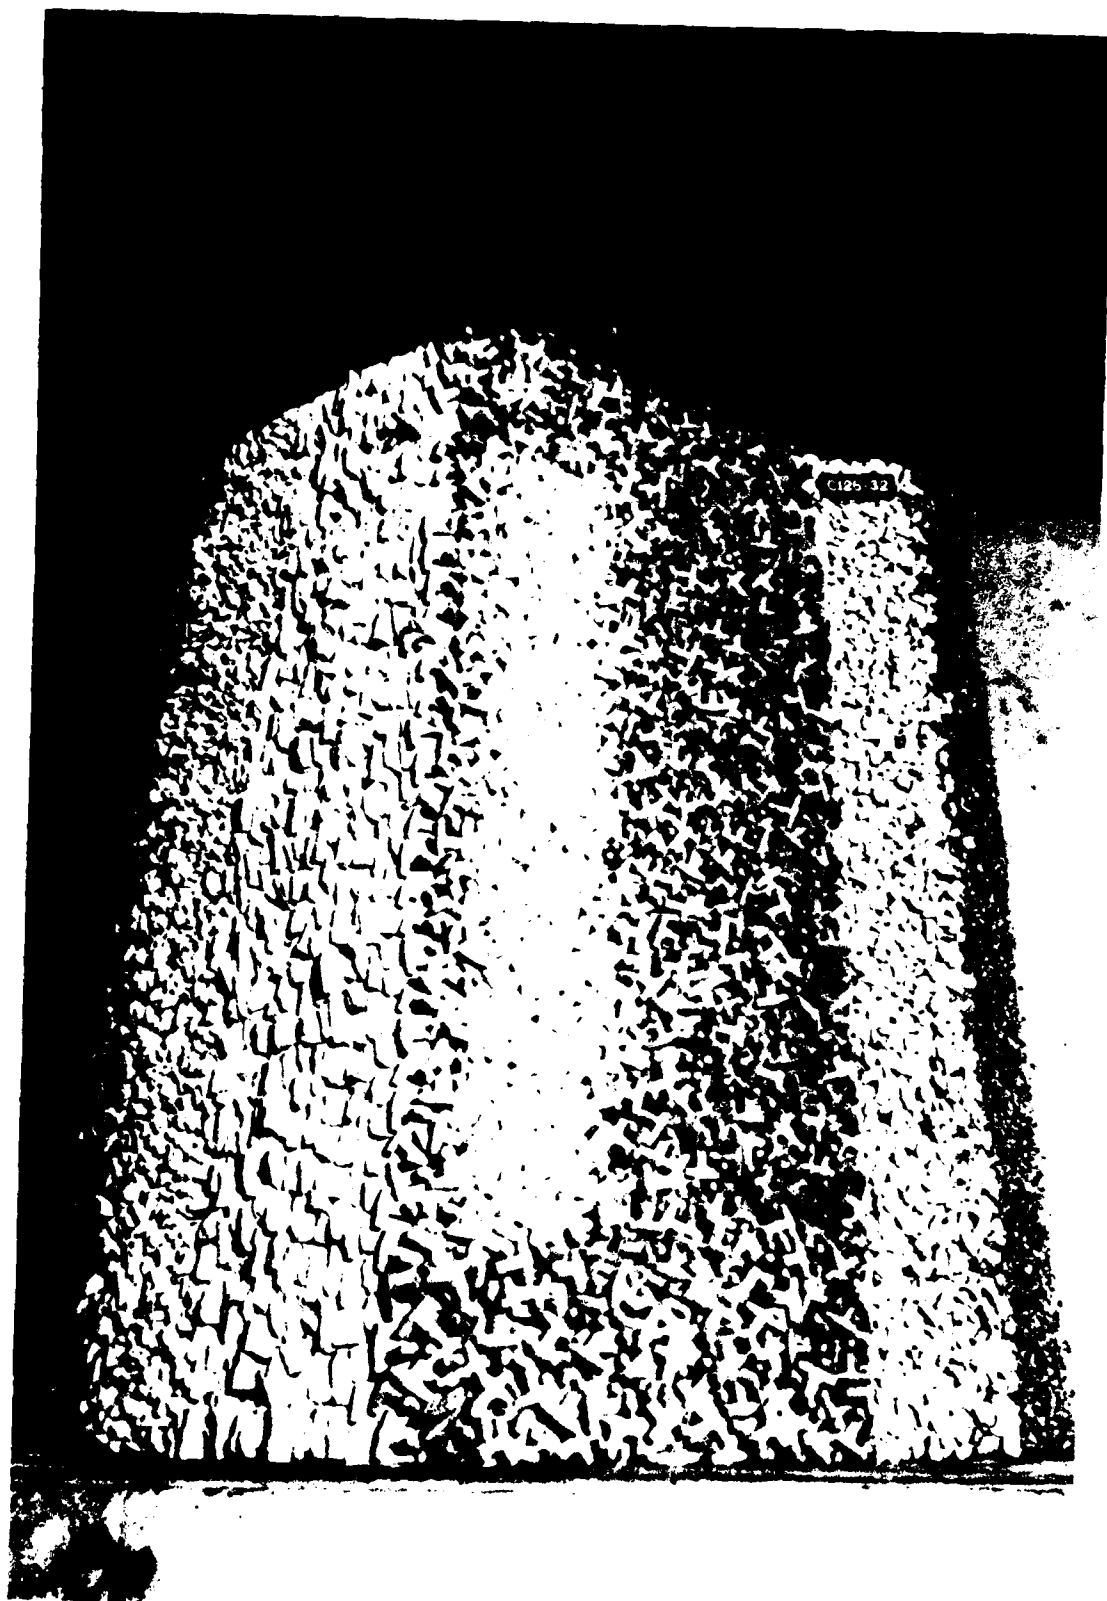
Photo 30. Overhead view of Plan 2 after testing Hydrograph D,  
second test section

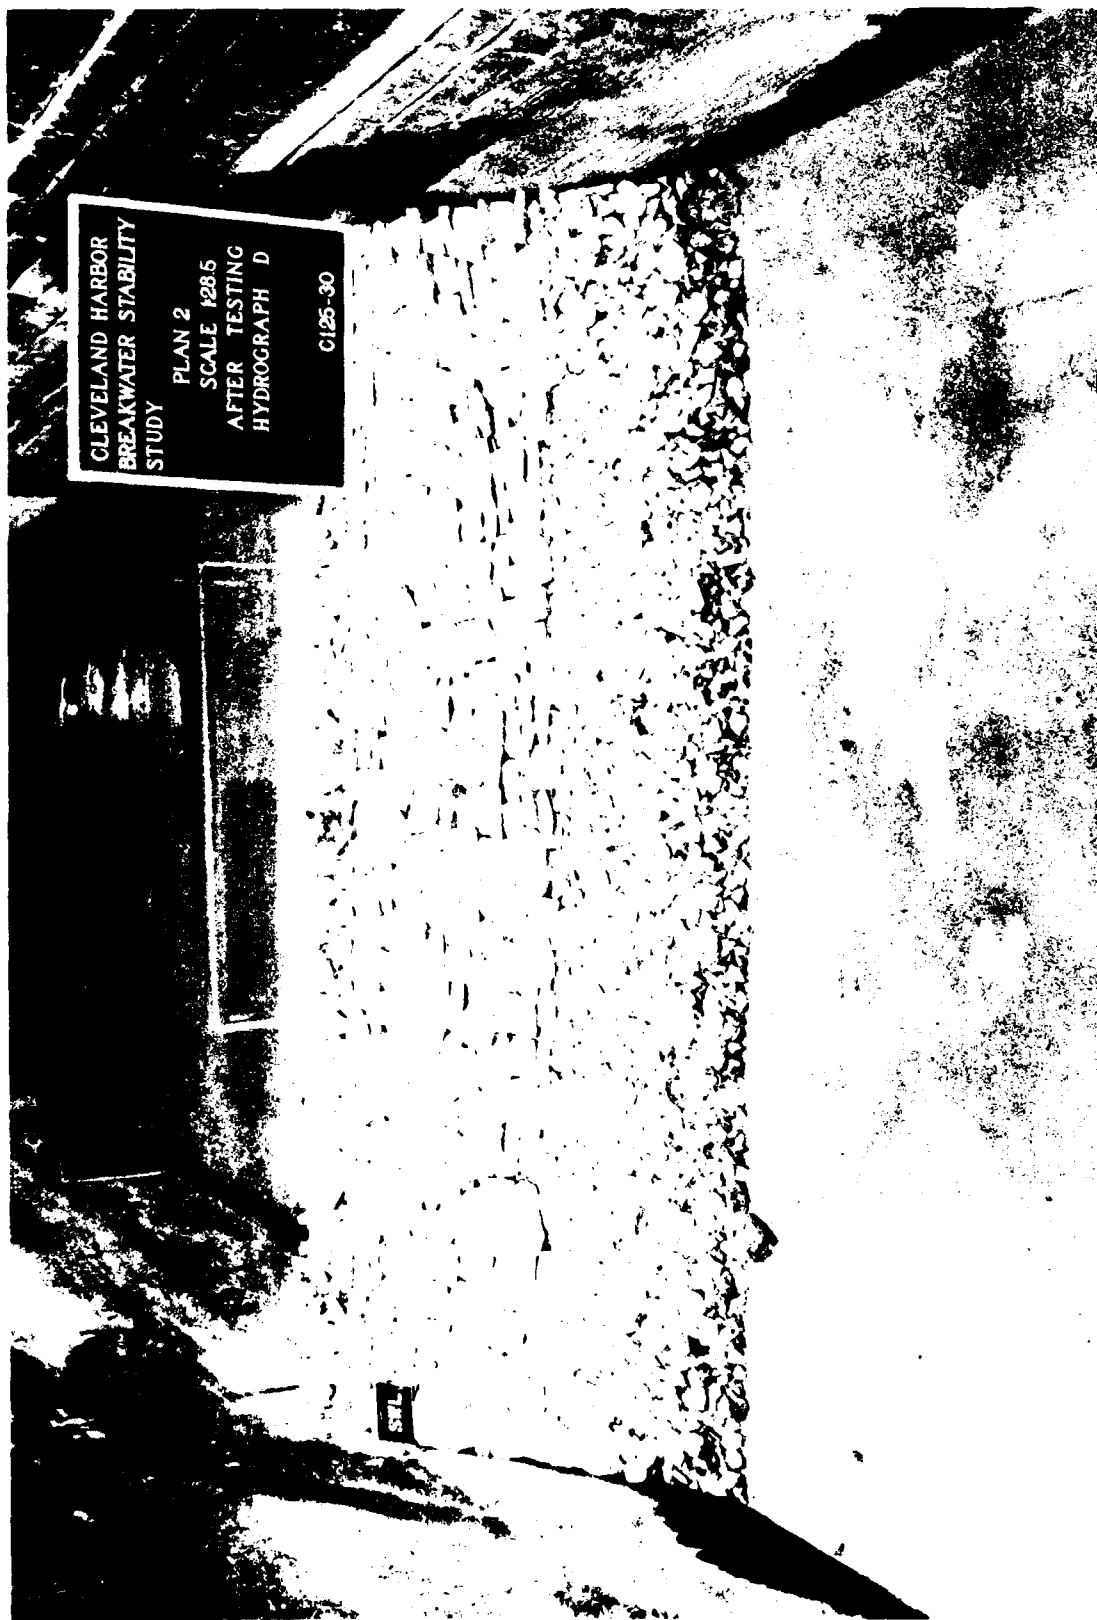
Photo 31. Harbor-side view of Plan 2 after testing Hydrograph D, second test section

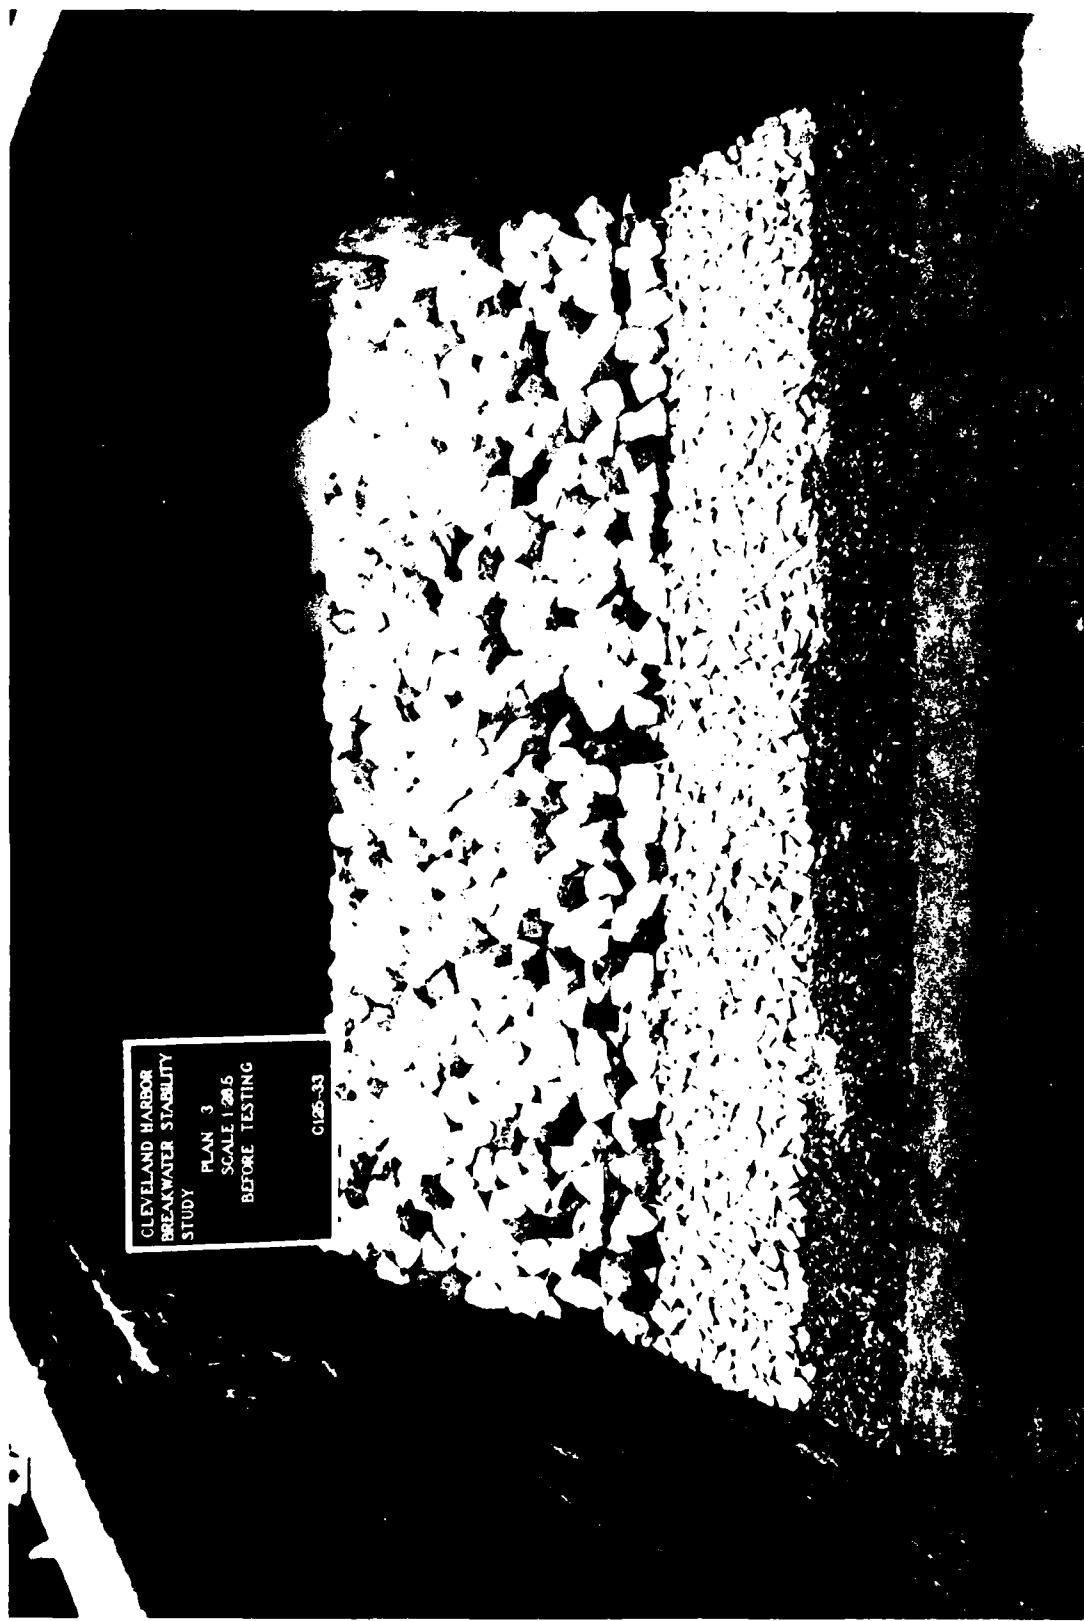
Photo 32. Lakeside view of Plan 3 before testing, first test section

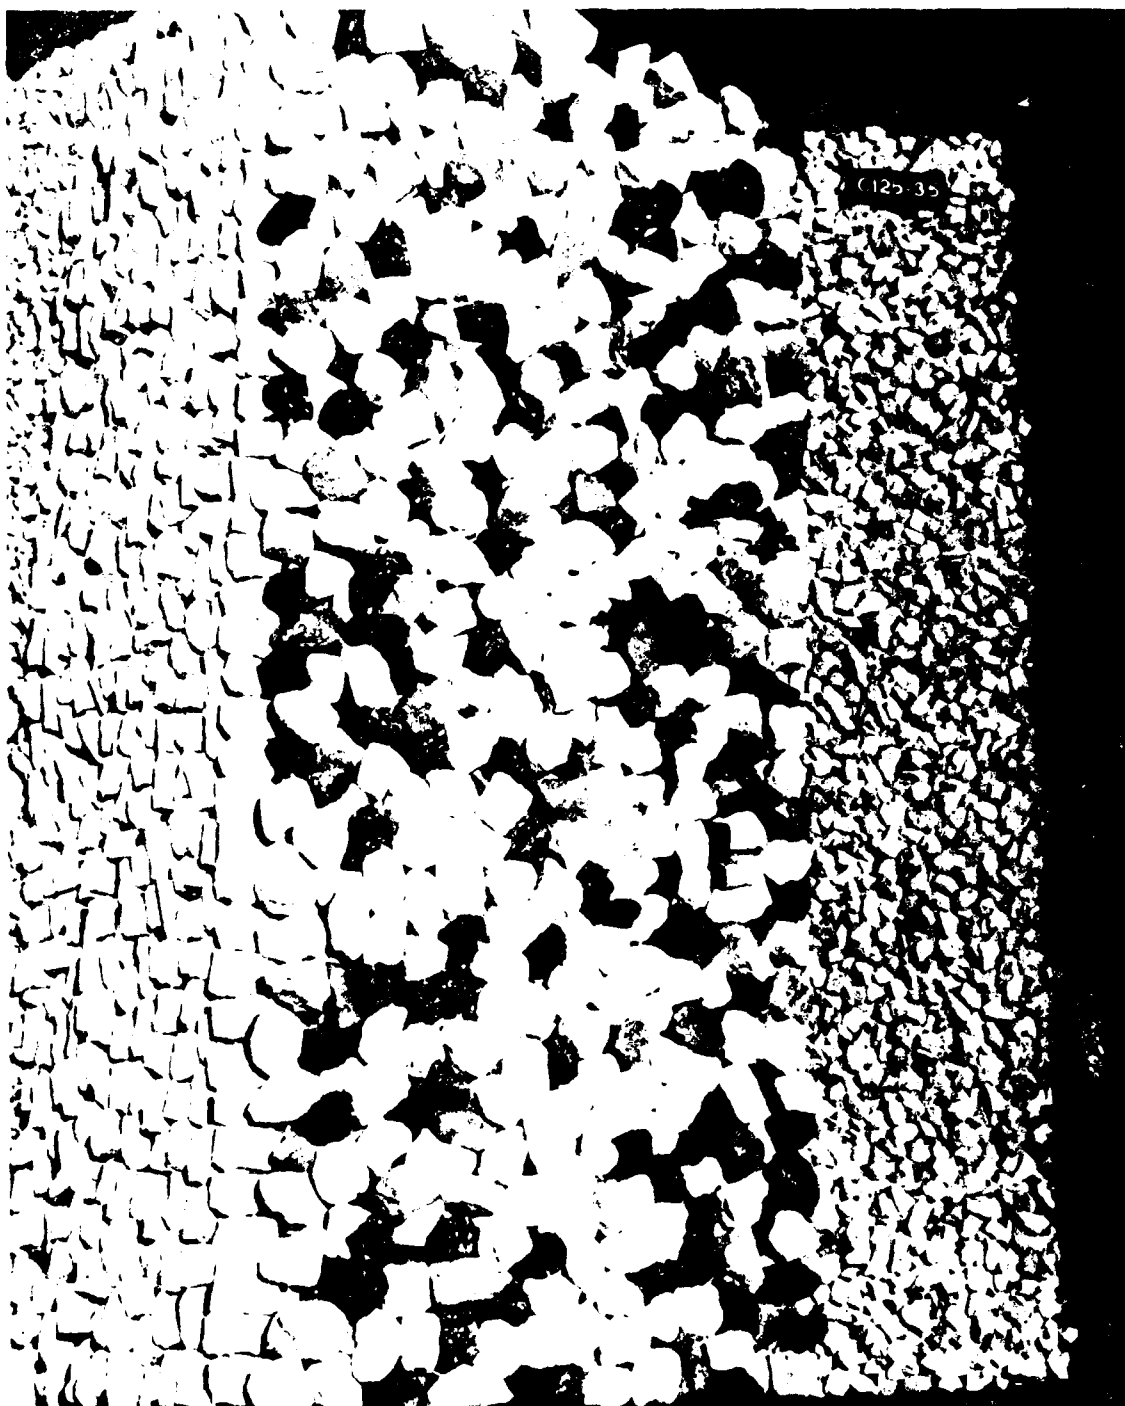
Photo 33. Overhead view of Plan 3 before testing, first test section

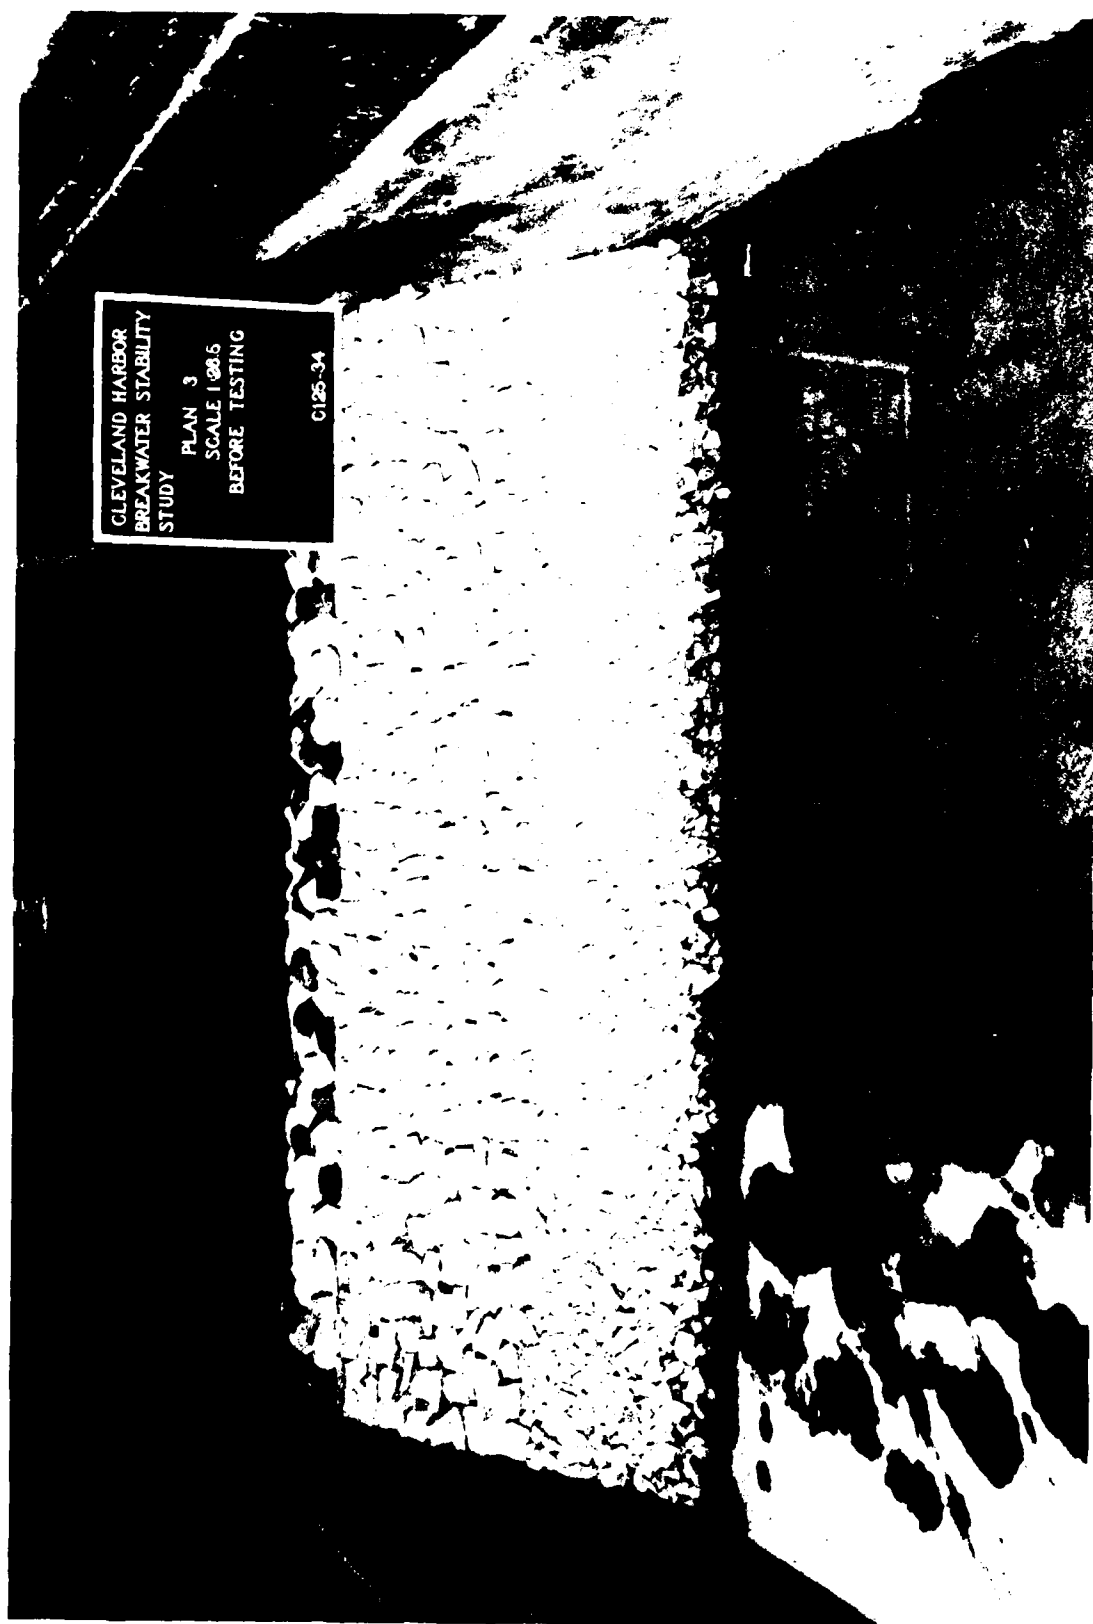
Photo 34. Harbor-side view of Plan 3 before testing, first test section

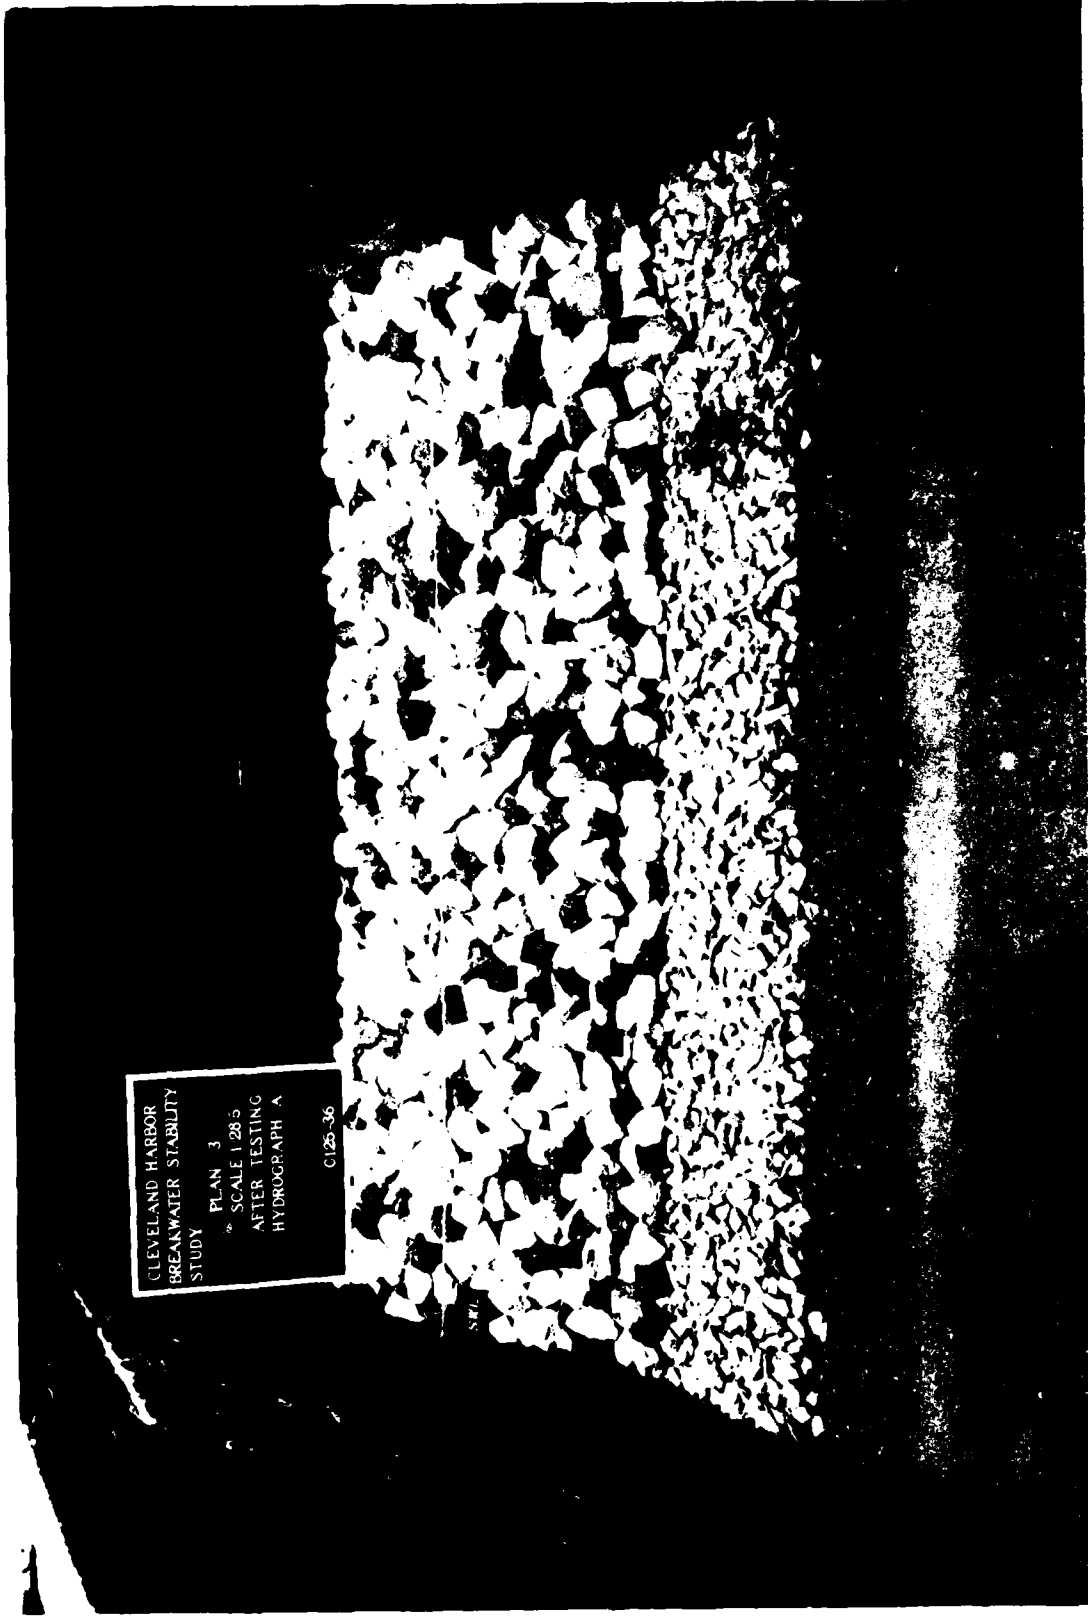
Photo 35. Lakeside view of Plan 3 after testing Hydrograph A, first test section

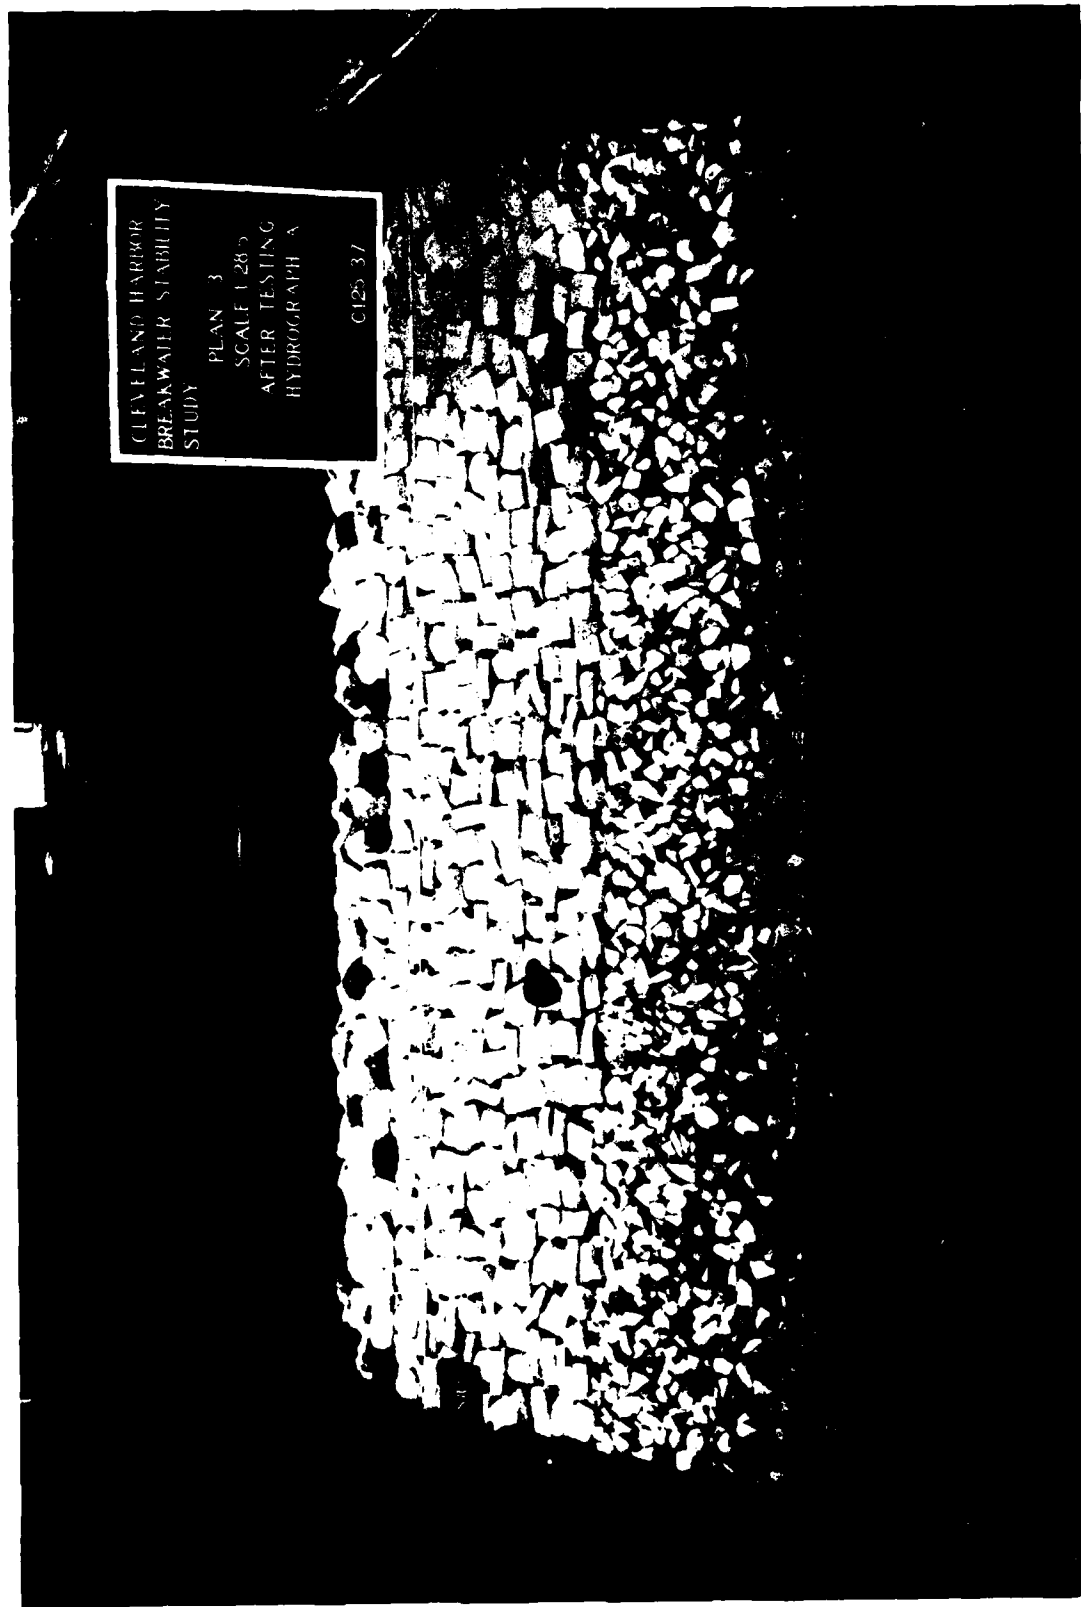
Photo 36. Overhead view of Plan 3 after testing Hydrograph A,  
first test section

slope, while the 13.4-ft waves caused some armor-stone displacement in these same areas. Based on these observations, Plan 3 (Photos 32-34) was exposed to the wave and swl conditions of Hydrograph A. During Step 1, two stones at the swl were displaced downslope and one crown stone was displaced down the harbor-side slope. Two additional stones were displaced downslope from the swl during Step 2. Five additional armor stones (one on the crown and four at the swl) showed moderate to significant in-place rocking throughout the test. No armor-stone displacement occurred during Step 3 and the structure was in good condition (slight to minor spot damage on crown and around swl) at the end of the test (Photos 35-37). The displaced armor stone and stone exhibiting in-place rocking during this test ranged in weight from the smallest to largest in the graded armor-stone mix.

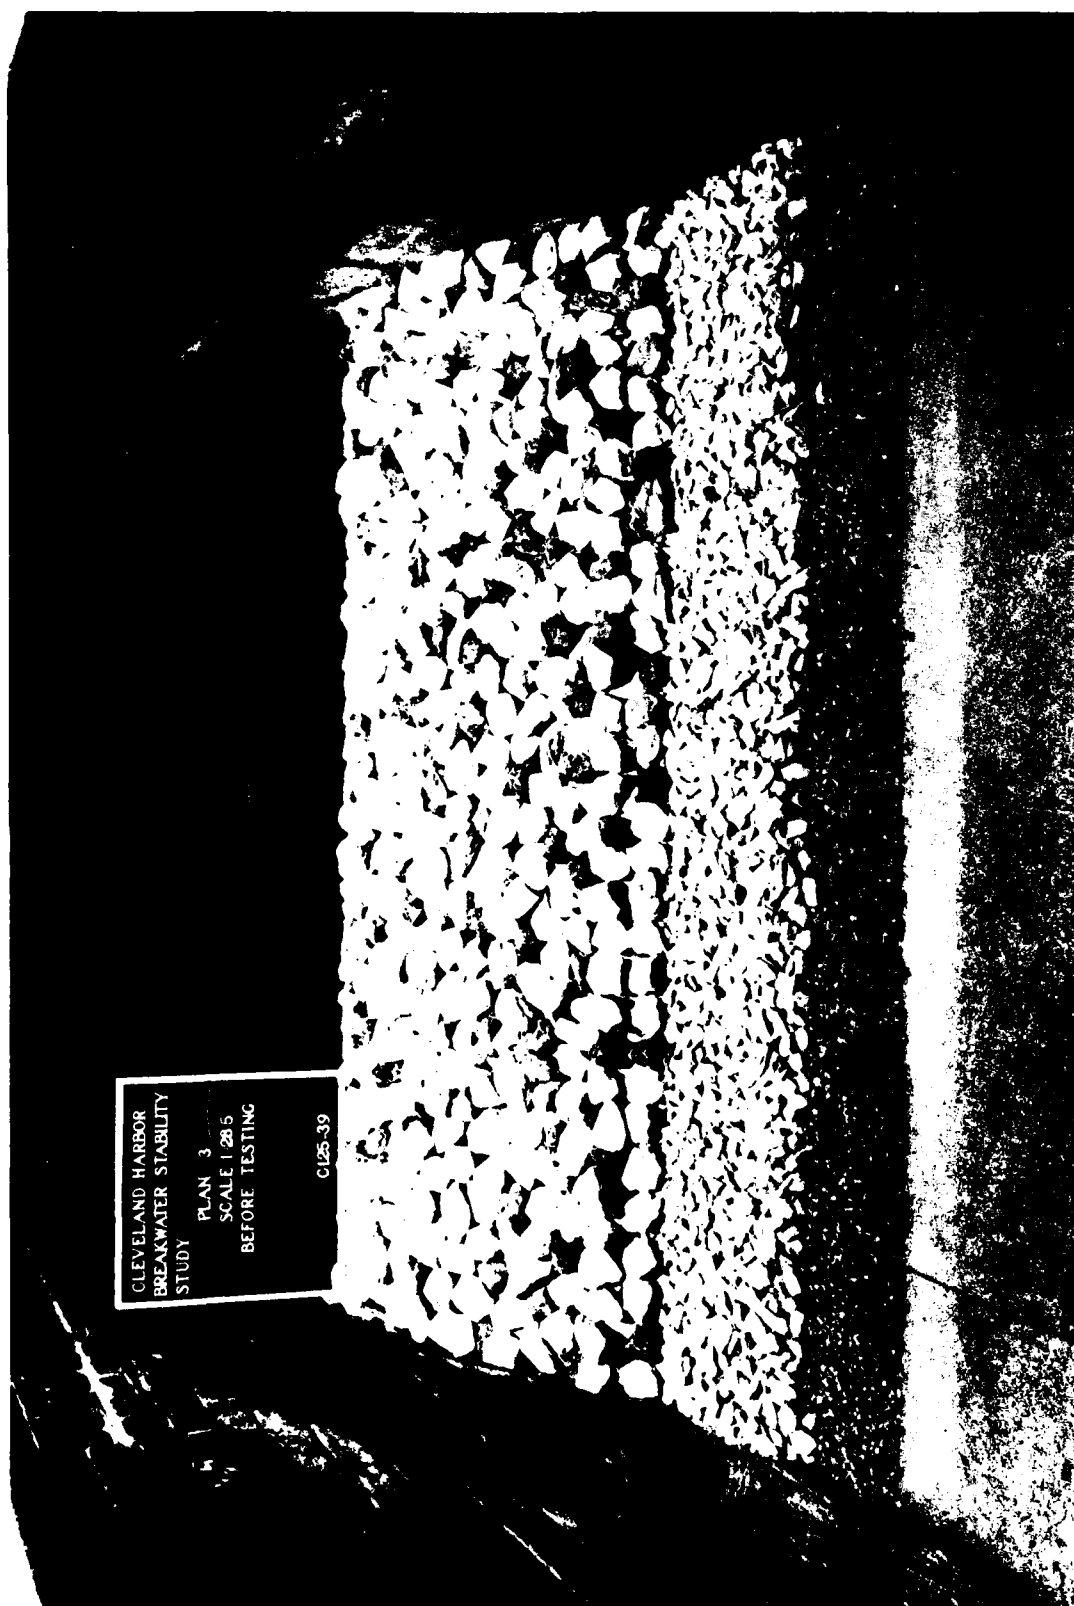
Photo 37. Harbor-side view of Plan 3 after testing Hydrograph A, first test section

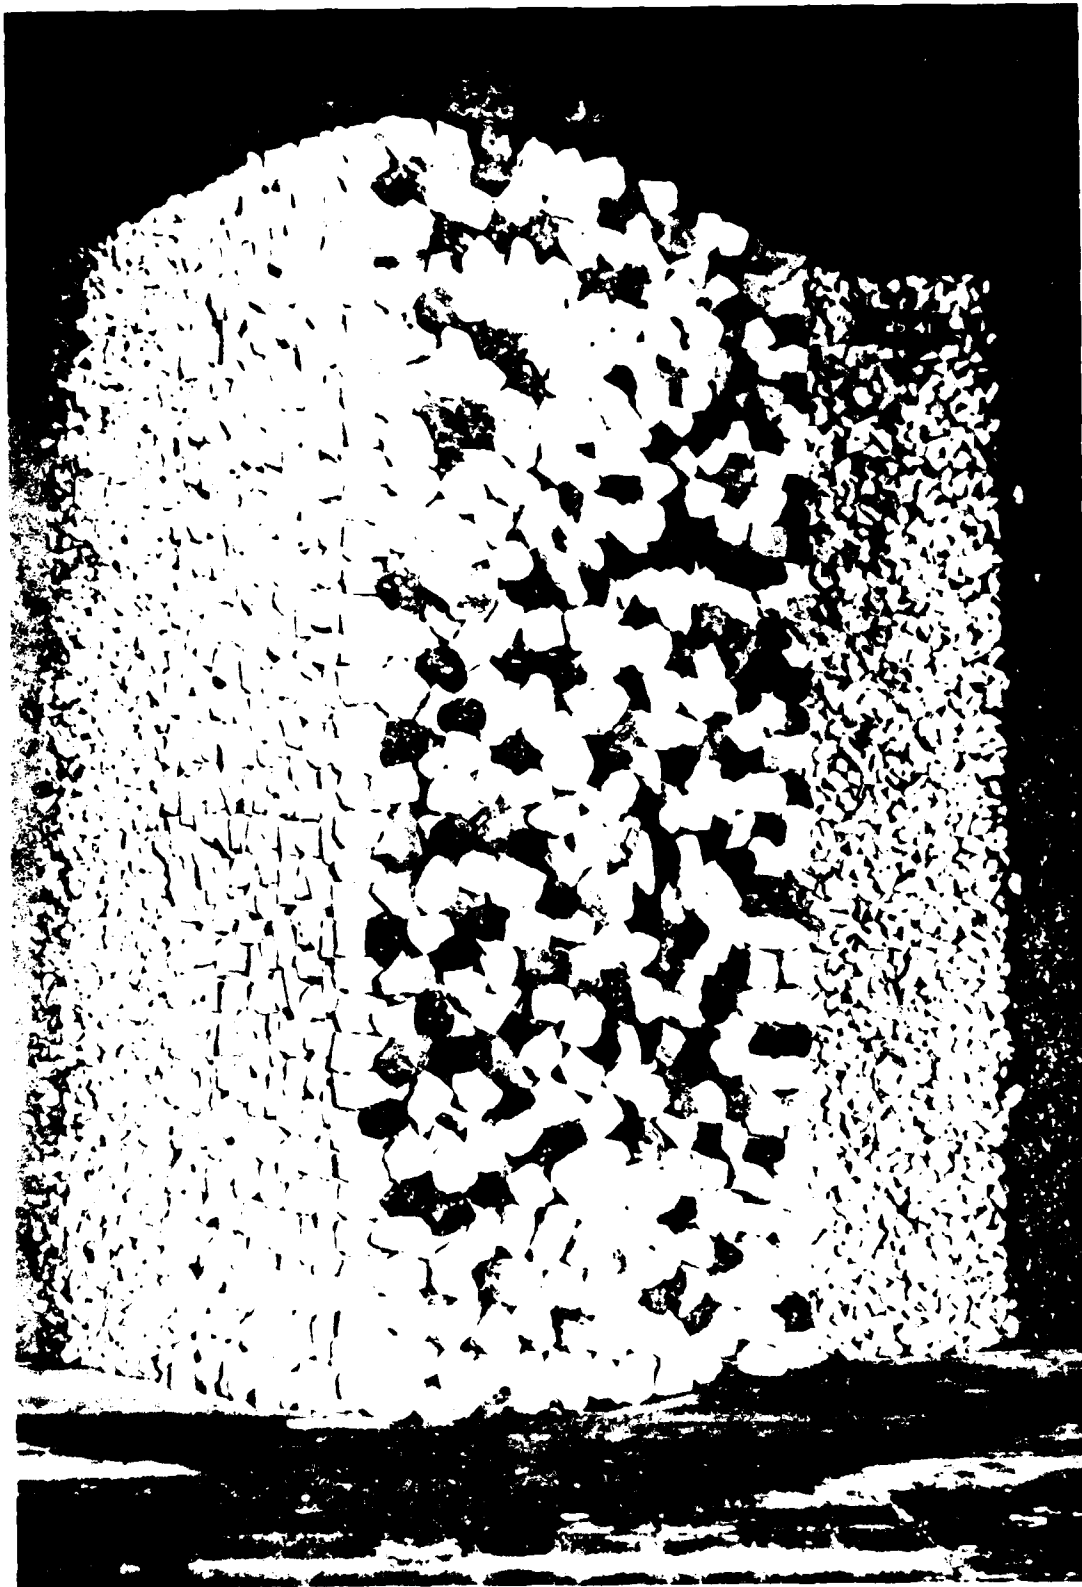
Photo 38. Lakeside view of Plan 3 before testing, second test section

27. The 9- to 20-ton armor stone was rebuilt (Photos 38-40) and Plan 3 was once again exposed to Hydrograph A. The structure accrued less damage during this testing. Three armor stones were displaced (two on the crown and one at the swl on the lakeside slope) during Steps 1 and 2. No displacement occurred during Step 3, but two armor stones on the crown and three at the swl continued to show minor to significant in-place rocking and reorientation throughout the test. Photos 41-43 show that the structure was in good condition (slight spot damage on crown and around swl) at the end of the test.

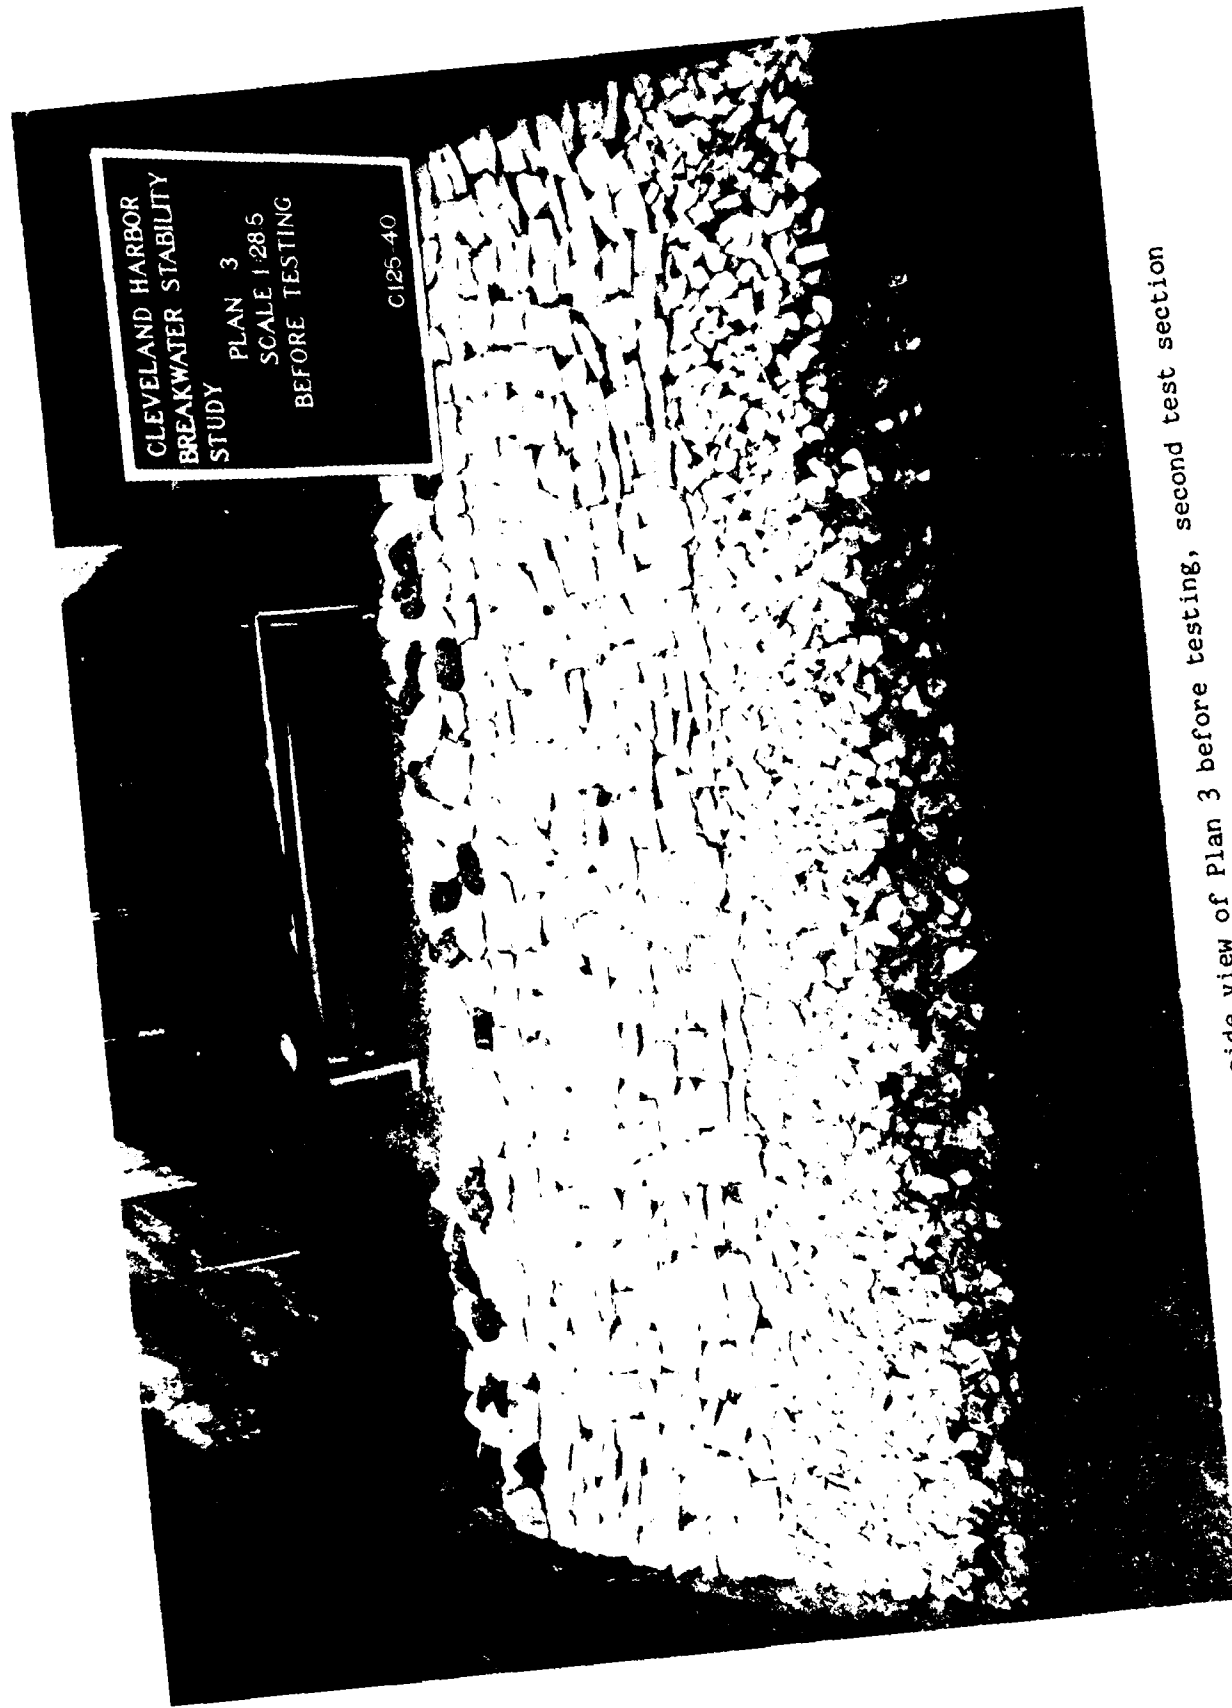
Photo 39. Overhead view of Plan 3 before testing,  
second test section
